INSPECTION REPORT

**1400 East State Street
Any town, Any state 08873**

**PREPARED BY
LEWIS HOME INSPECTION INC.**

Report: Commercial Web

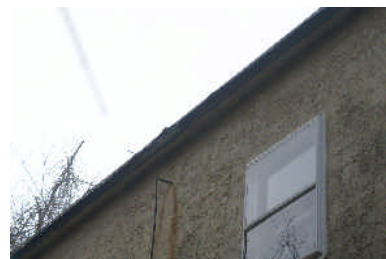
Water damage was noted on the rear fascia board. Weathered trim was noted on the south wall.

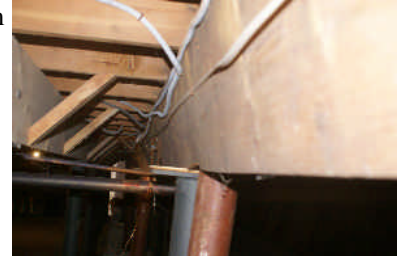
CONDITION Structural modifications were made on one beam in the basement. Obtain paperwork from engineer.

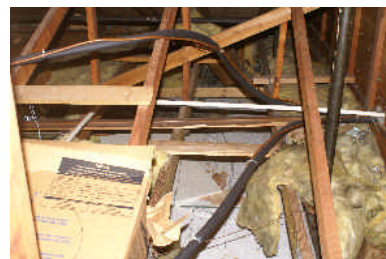
Attic requires re-insulation. Most insulation was displaced.

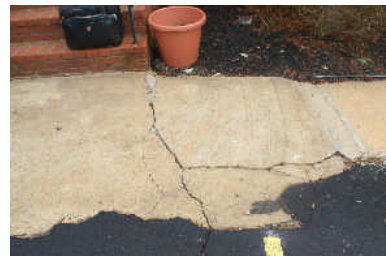
Repairs are required to prolong the life. Major cracks were noted. Repair is required.

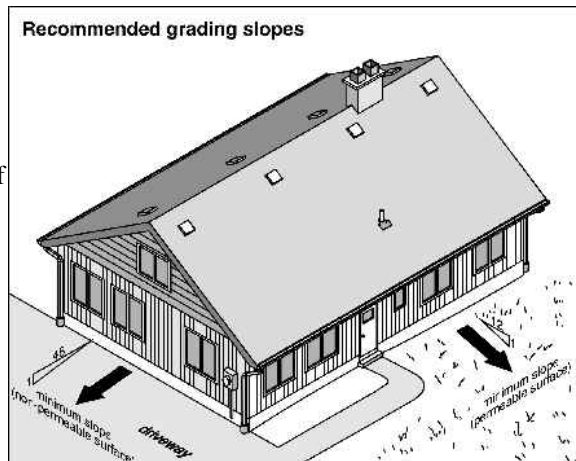
The site is noted to be flat. Grade at foundation needs improvement. Pitch slope of soils away from foundation. Slope should fall away from the foundation at a minimum of 1/2 inch per foot and extend at least four to five feet away from the foundation.

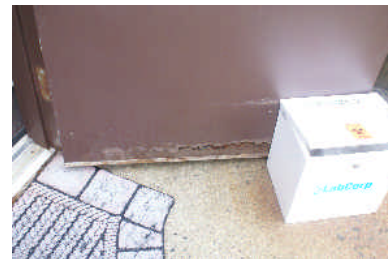
Side entry door was rusted through.

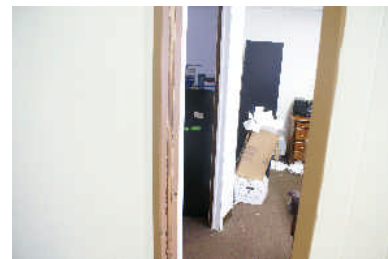
Adjustments needed to operate properly. One door was not closing in unit #301 and #303. Missing door in unit #203.

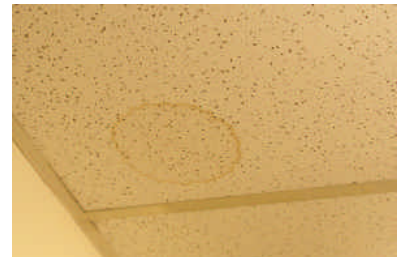
Most ceiling tiles require replacement. Stains were noted in the first and second level offices. No moisture was detected.

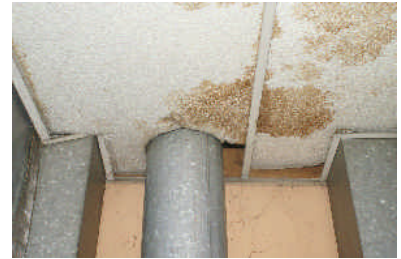
Exhaust pipe in the utility room was too close to combustibles.

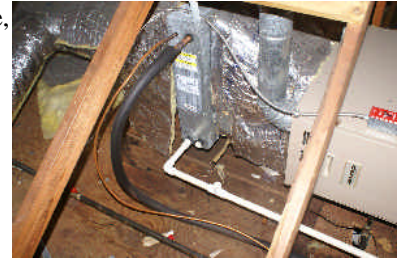
Appears to be in serviceable condition. One unit is an older system. Replacement must be anticipated in the near future.

In order to reduce the potential for water damage, it is recommended that an auxiliary drain pan be installed below the indoor component of the air conditioning system.

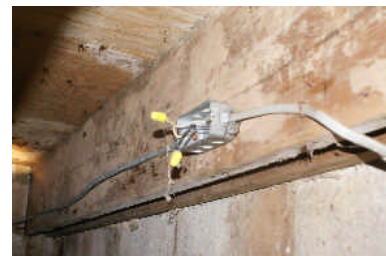
Copper. Open junction boxes are noted which is a hazard i the basement.
